APPENDICES I-IX

**CONDITION ASSESSMENT AND EVALUATION OF ROCK
REINFORCEMENT**

BARRON MOUNTAIN ROCK CUT

WOODSTOCK, NEW HAMPSHIRE

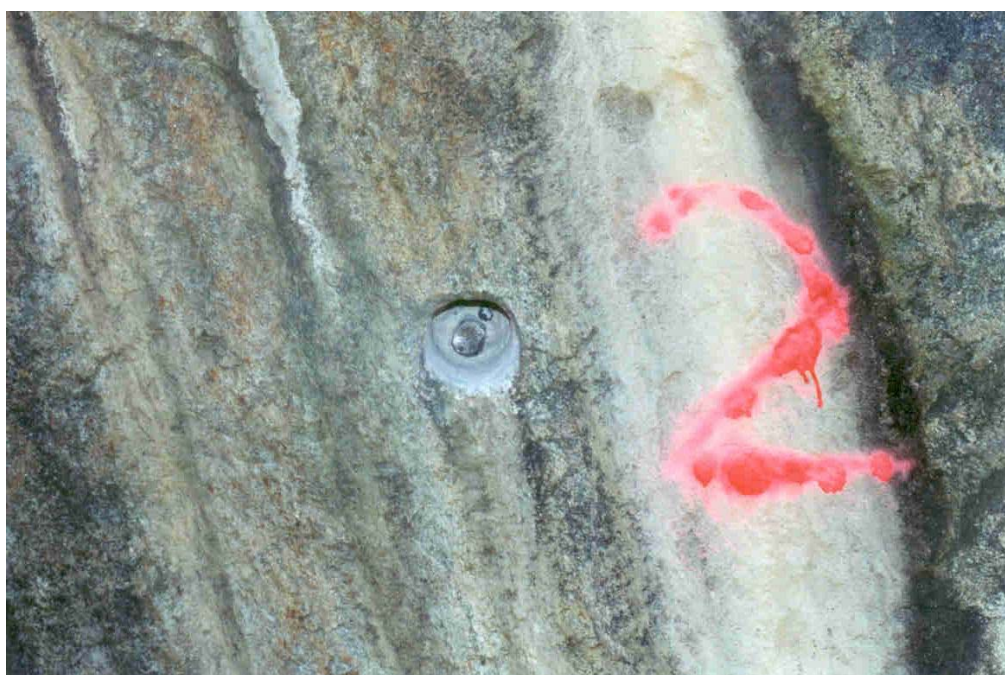
Photograph 2 – Exposed end of Tendon 2-1 after chipping

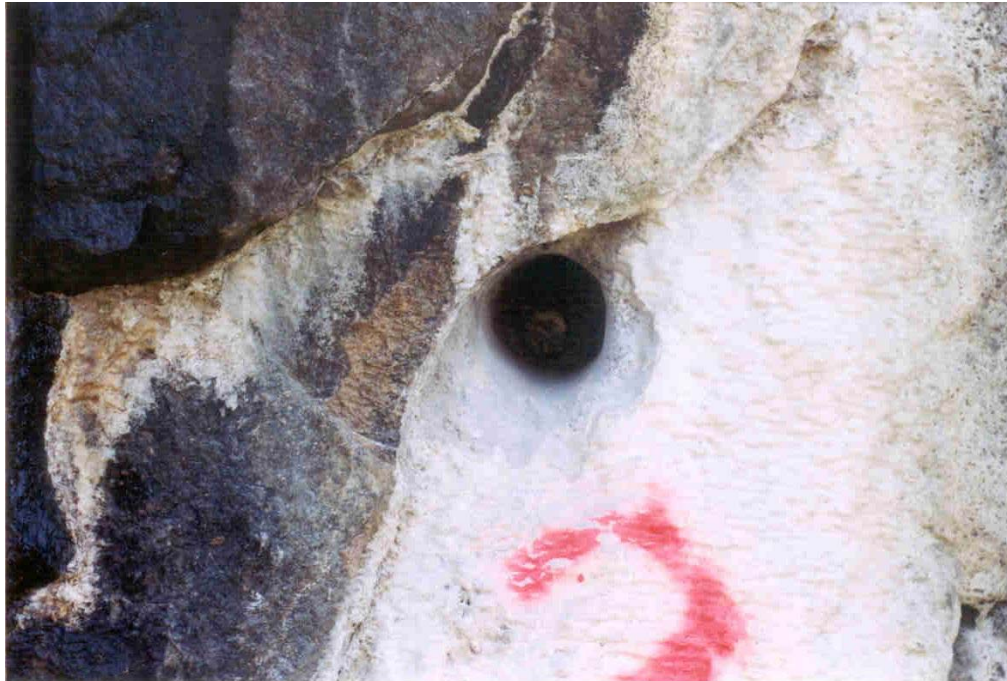
Photograph 3 – Exposed end of Tendon 2-2 after chipping

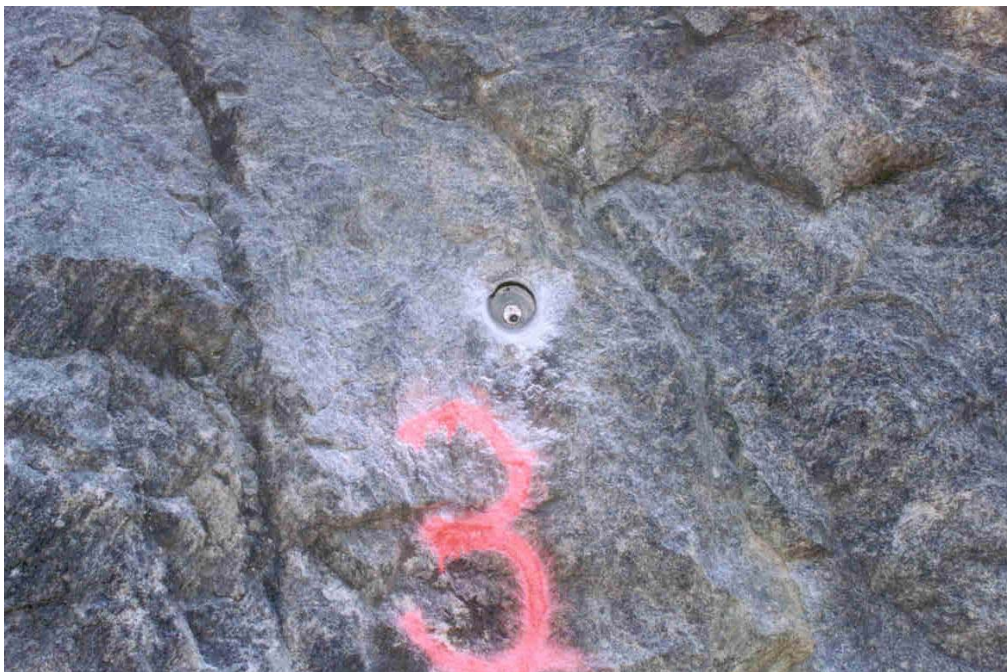
Photograph 4 – Exposed end of Tendon 3-1 after chipping

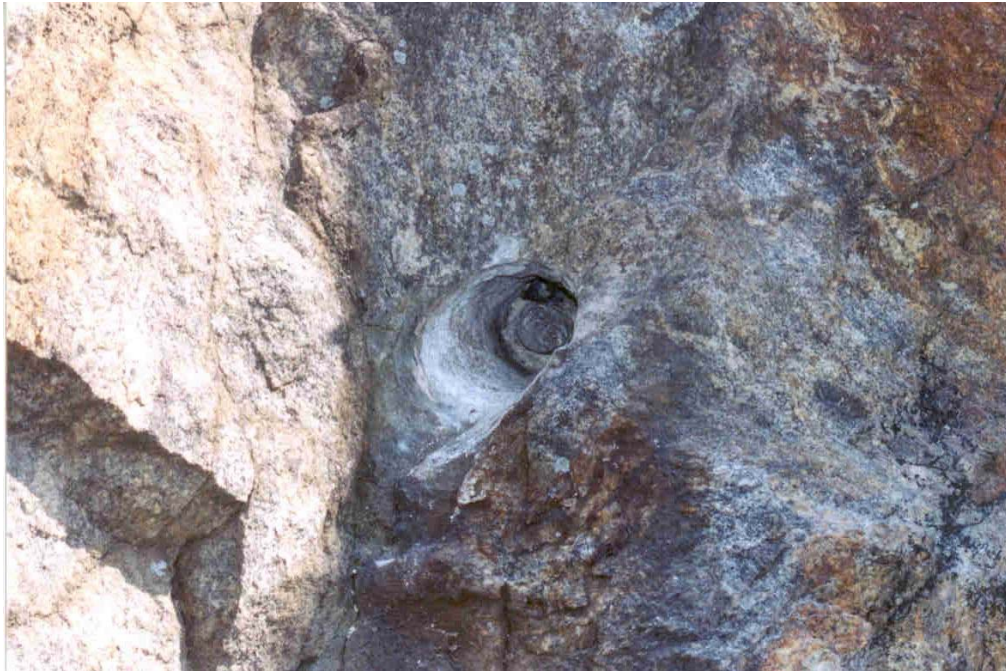
Photograph 5 – Exposed end of Tendon 3-2 after chipping

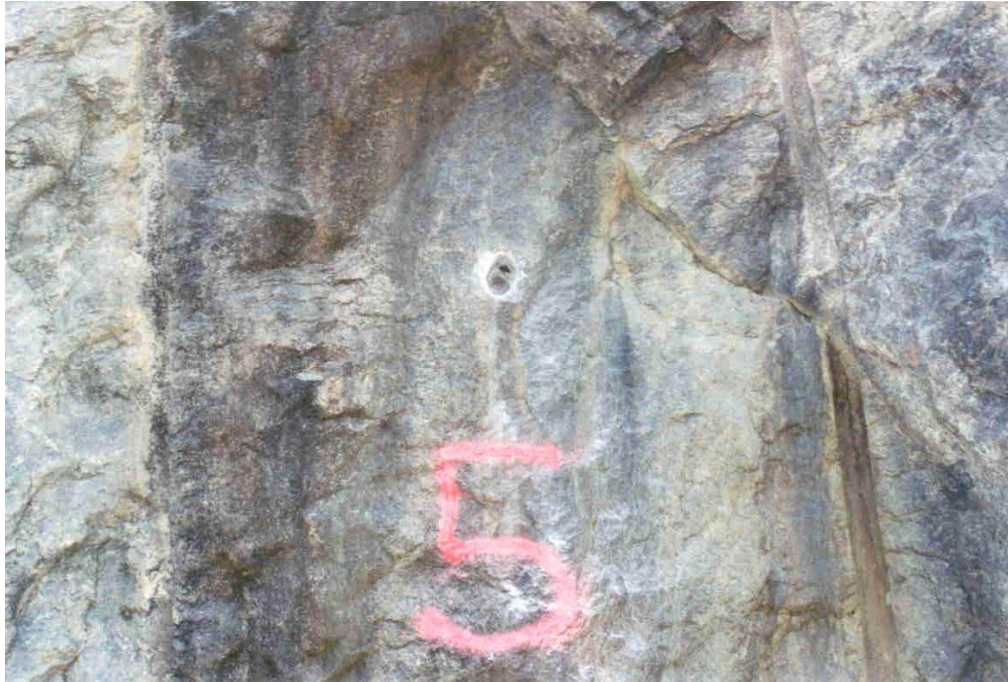
Photograph 9 – Exposed end of Tendon 5-2 after chipping

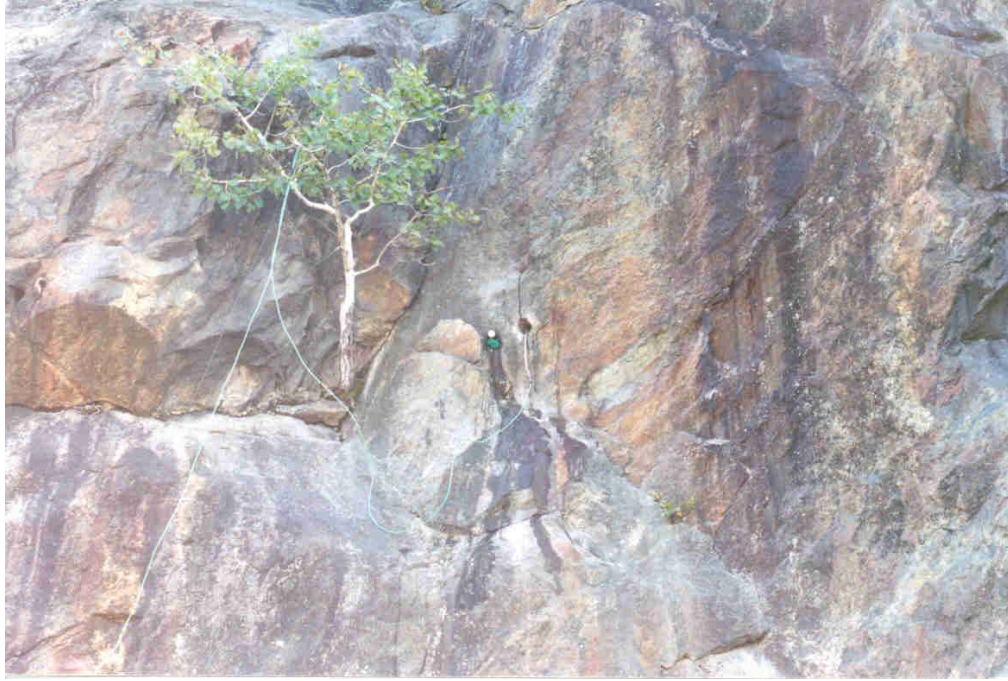
Photograph 1 – Half-cell location for Tendons 1-3 and 1-4.

Tendon #	Half-Cell Location
1-1	Drill-hole adjacent to Tendon 1-1
1-2	Drill-hole adjacent to Tendon 1-1
1-3	Drill-hole approx. 6" North of Tendon 1-4 ; see Appendix II, Photo #1
1-4	Drill-hole approx. 6" North of Tendon 1-4; see Appendix II, Photo #1
2-1	Drill hole approx. 18" South and above Tendon 2-1
2-2	Drill hole approx. 18" South and above Tendon 2-1
2-3	Approx. 10 ft. North of Tendon 2-3
2-4	Vertical drill-hole approximately 3 ft. above Tendon 2-4; see Appendix II, Photo #2
3-1	Rock joint approx. 4 ft. North and above Tendon 3-2; see Appendix II, Photo #3
3-2	Rock joint approx. 4 ft. North and above Tendon 3-2
3-3	Rock joint between and to the North of Tendons 3-3 and 3-4
3-4	Rock joint between and to the North of Tendons 3-3 and 3-4
4-1	Rock joint approx. 3 ft. S. of Tendon 4-1 and 5 ft. N. of Tendon 4-2; see Appendix II, Photo #4
4-2	Rock joint approx. 3 ft. S. of Tendon 4-1 and 5 ft. N. of Tendon 4-2

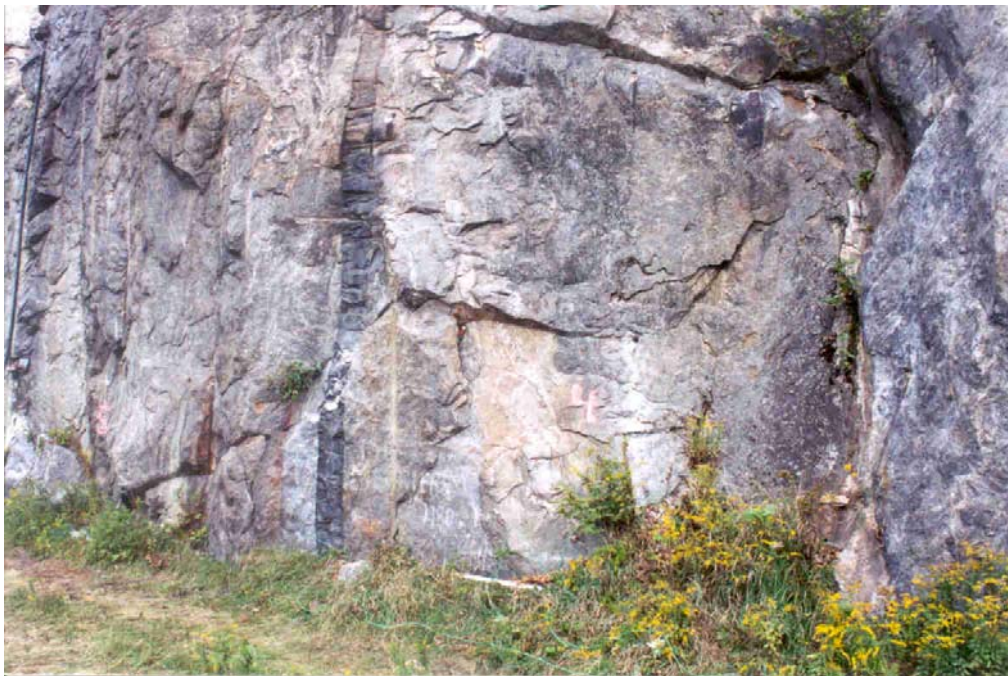
Photograph 4 – Half-cell location for Tendons 4-1 and 4-2. Half-cell is located at the intersection of the vertical and horizontal crevices in the center of the photograph.

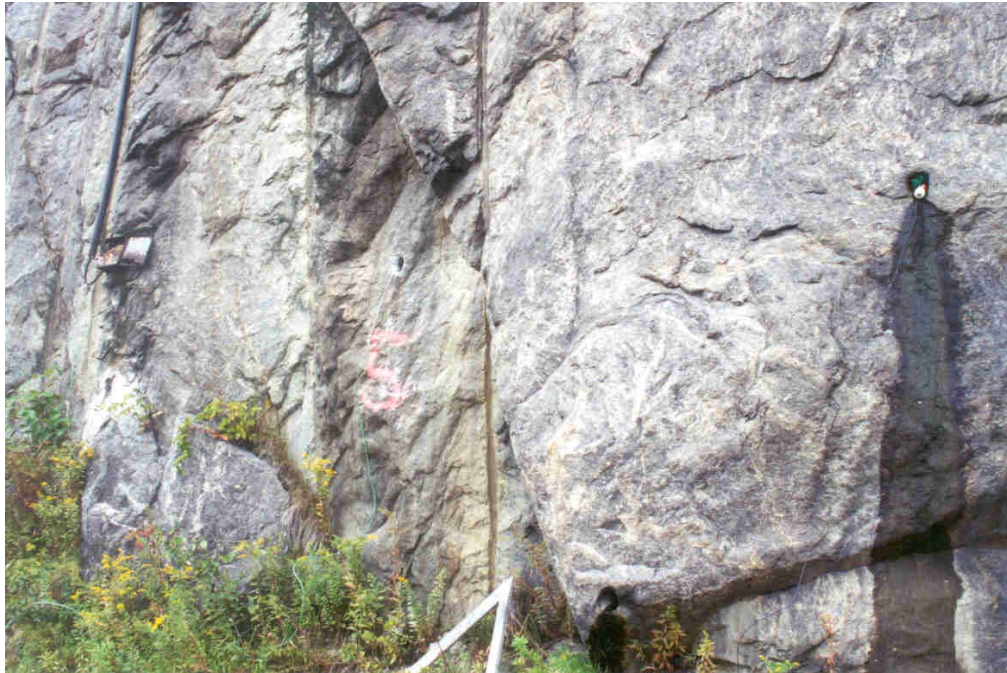
Photograph 5 – Half-cell location for Tendons 5-1 and 5-2. Half-cell is placed in the hole directly above the water stain (right).

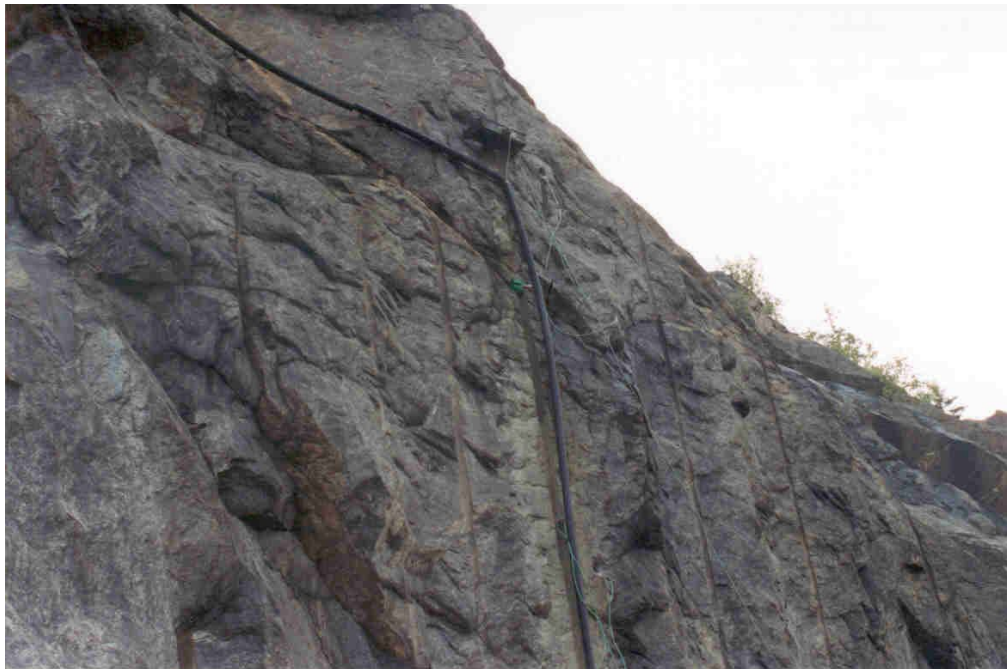
Photograph 6 – Half cell location for Tendons 5-3 and 5-4. Half-cell is placed beneath the black cable conduit approximately three-quarters of the way up the vertical section located in the center of the photograph.

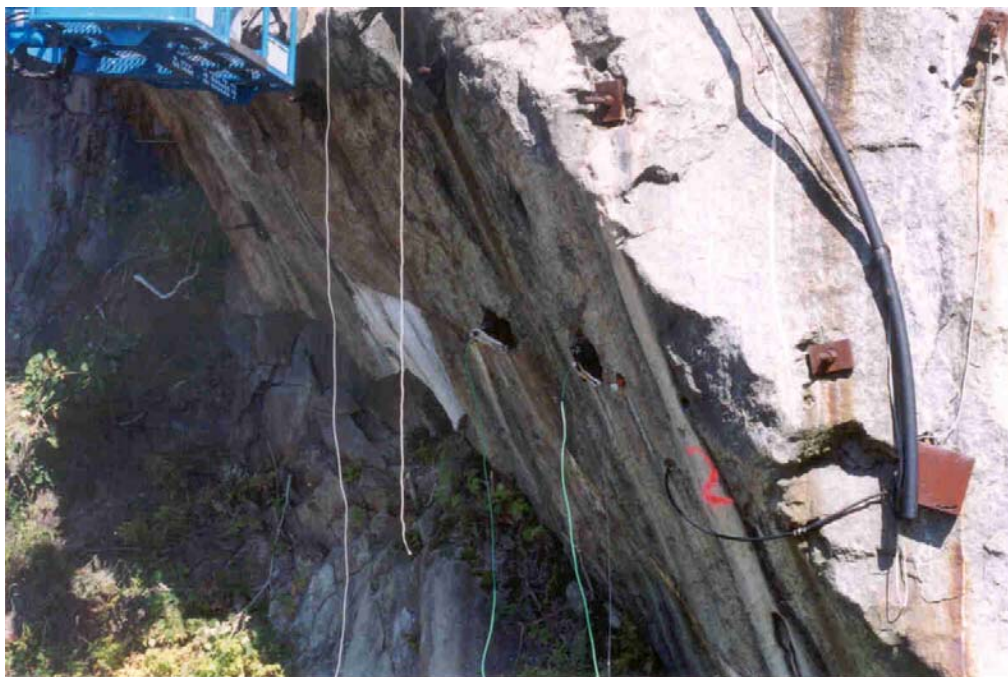
Photograph 7 – Half-cell location for Bolts 1 and 2. Half-cell was placed in a hole to the right of Bolts 1 and 2 (center).

Rock Bolt #	Half-Cell Location
1	Drill-hole 8 in. South of Bolt 2; see Appendix II, Photo #7
2	Drill-hole 8 in. South of Bolt 2; see Appendix II, Photo #7
3	Rock joint between bolts 3 and 4; see Appendix II, Photo #8
4	Rock joint between bolts 3 and 4; see Appendix II, Photo #8
5	Approx. 10 ft. North of Tendon 2-3
6	Approx. 10 ft. North of Tendon 2-3
7	Approx. 3 ft. South and above Bolt 8
8	Approx. 3 ft. South and above Bolt 8
9	Approx. 1.5 ft above Bolt 9; see Appendix II, Photo #9
10	Approx. 1.5 ft above Bolt 9; see Appendix II, Photo #9
11	Drill-hole below Bolt 11; see Appendix II, Photo #10
12	Drill-hole below Bolt 11; see Appendix II, Photo #10
13	Drill hole south of Bolt 14; see Appendix II, Photo #11
14	Drill hole south of Bolt 14; see Appendix II, Photo #11
15	Rock joint approx. 8 ft. above and South of Bolt 15; see Appendix II, Photo #12
16	Rock joint approx. 8 ft. above and South of Bolt 15; see Appendix II, Photo #12

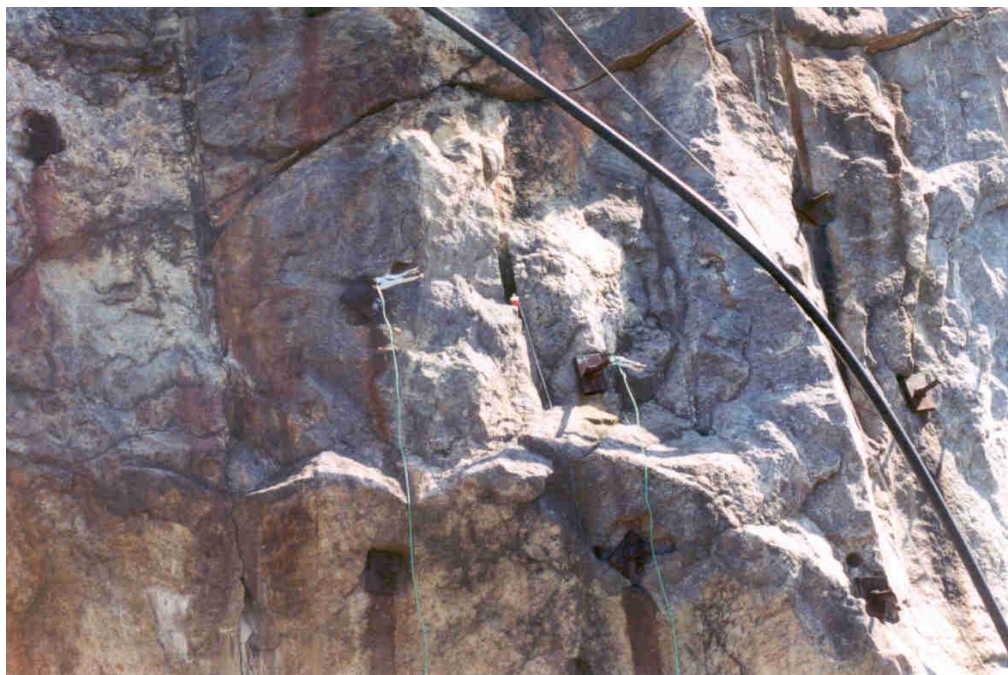
Photograph 8– Half-cell location for Bolts 3 and 4. Half-cell was placed in a vertical hole between Bolts 3 and 4 (center).

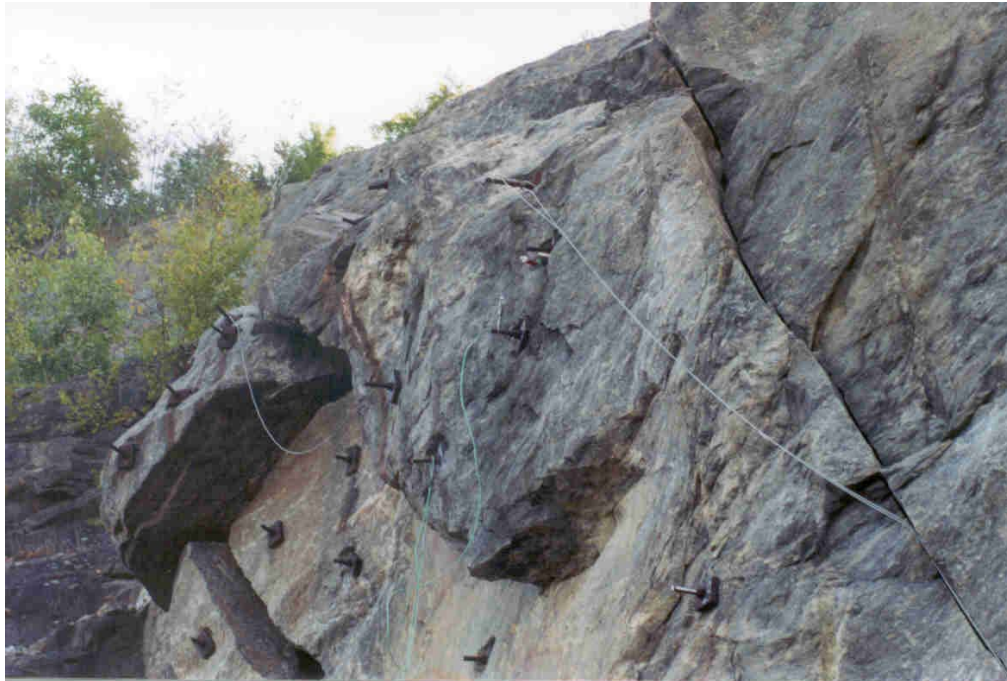
Photograph 9 – Half-cell location for Bolts 9 and 10. Half-cell was placed in a hole directly above Bolt 9 (center).

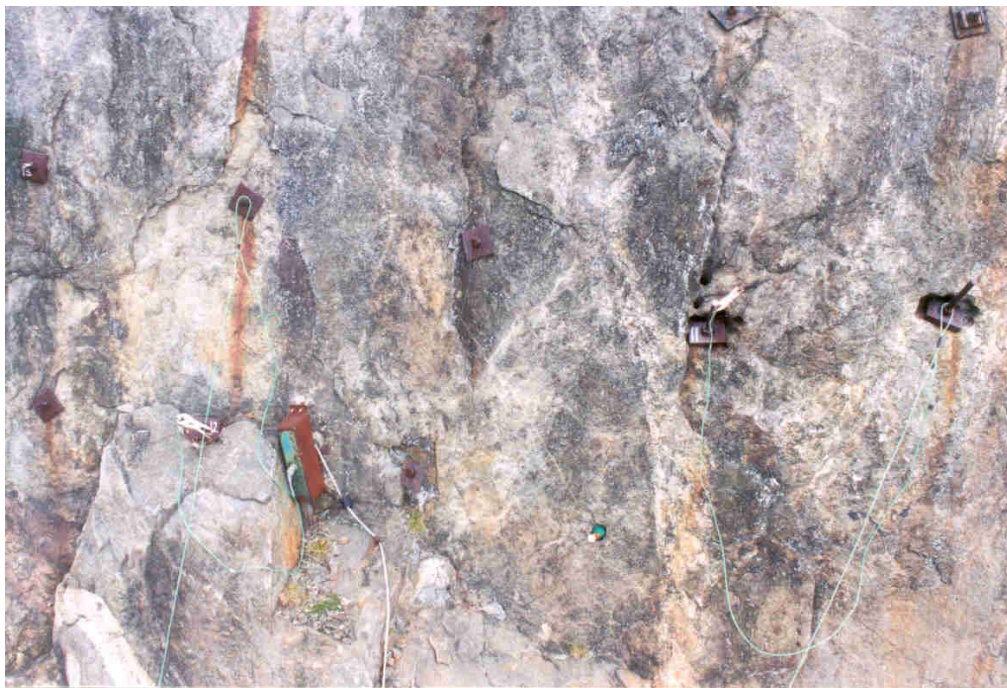
Photograph 10 – Half cell location for Bolts 11 and 12. Half-cell was placed in a hole between and below Bolts 11 and 12 (lower center).

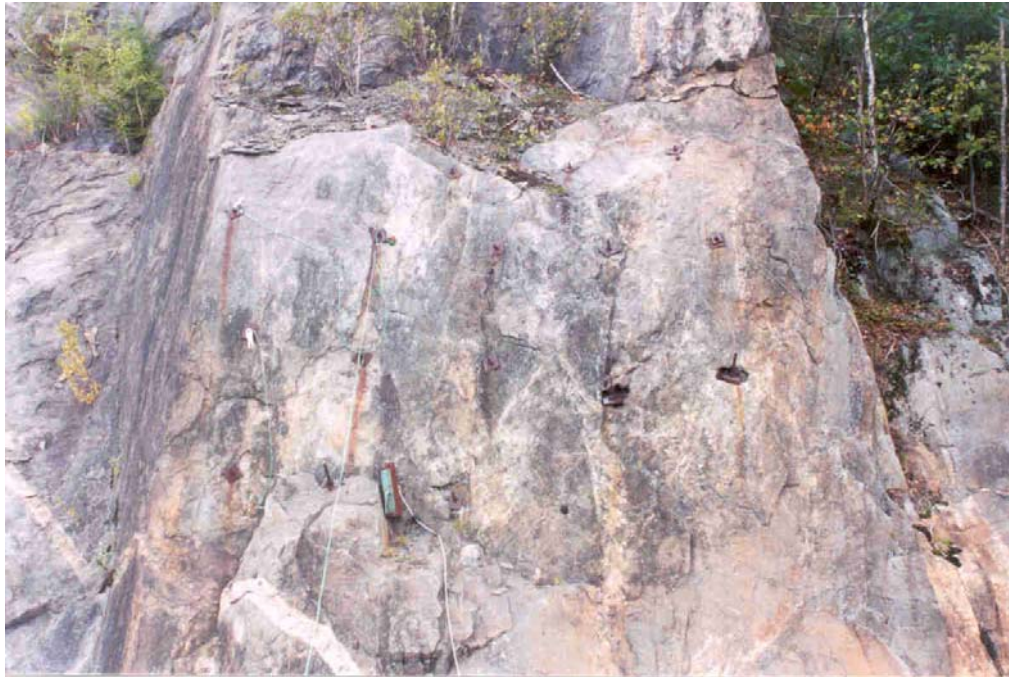
Photograph 11 – Half-cell location for Bolts 13 and 14. Half-cell was placed in a hole to the right of Bolts 13 and 14 (left center).

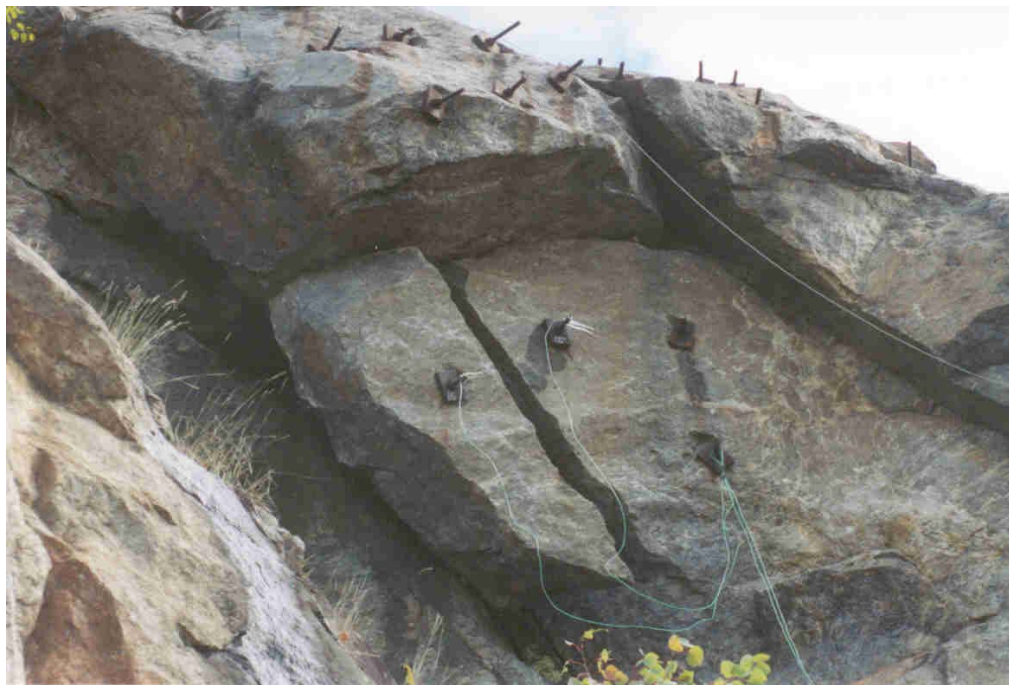
Photograph 12 – Half-cell location for Bolts 15 and 16. Half-cell was placed in the horizontal crevice, right of the near vertical crevice, in the center of the photo.

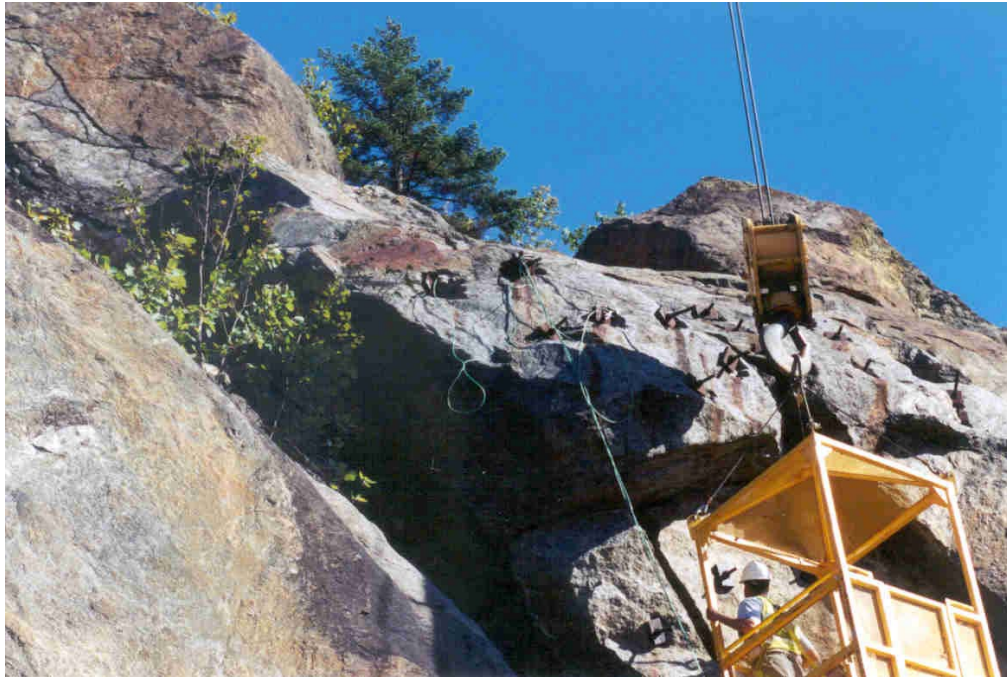
Photograph 13 – Half-cell location for Bolts 17 and 18. Half-cell was placed in a small crack approximately 10 feet to the right of Bolt 18.

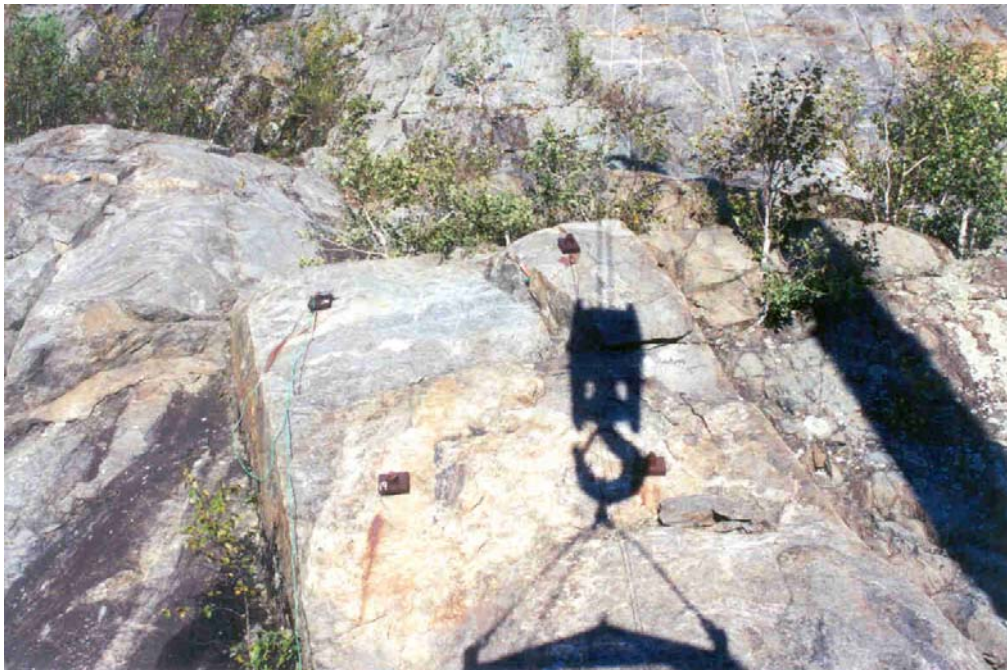
Photograph 14 – Half-cell location for Bolts 19 and 20. Half-cell was placed in the crack approximately 10 feet to the right of Bolt 20.

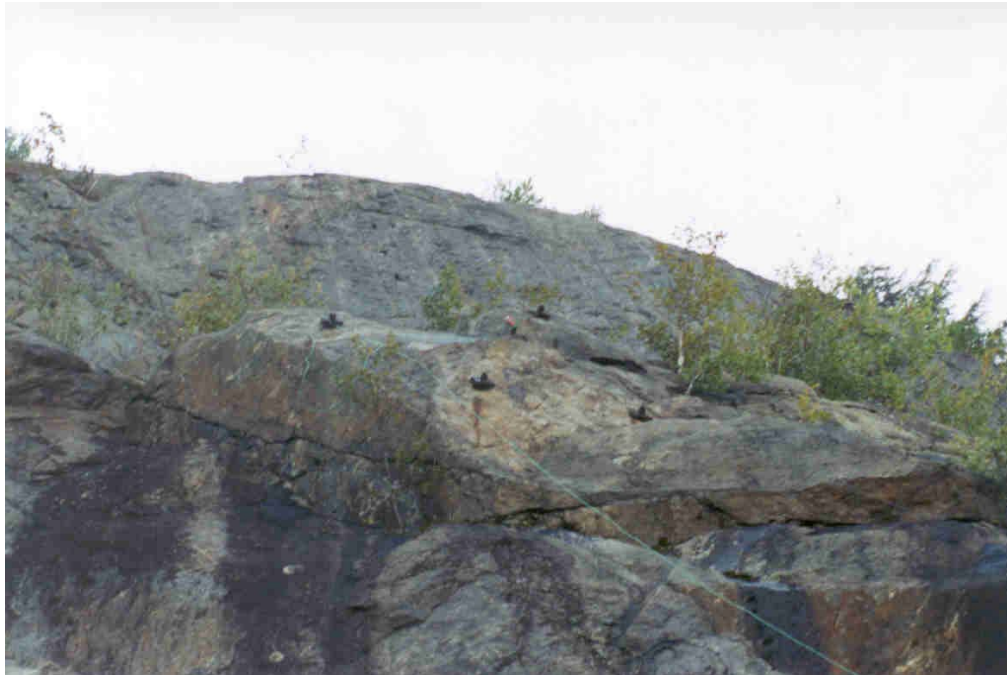
Photograph 15 - Half-cell location for Bolts 19 and 20. Half-cell was placed in the crack approximately 10 feet to the right of Bolt 20.

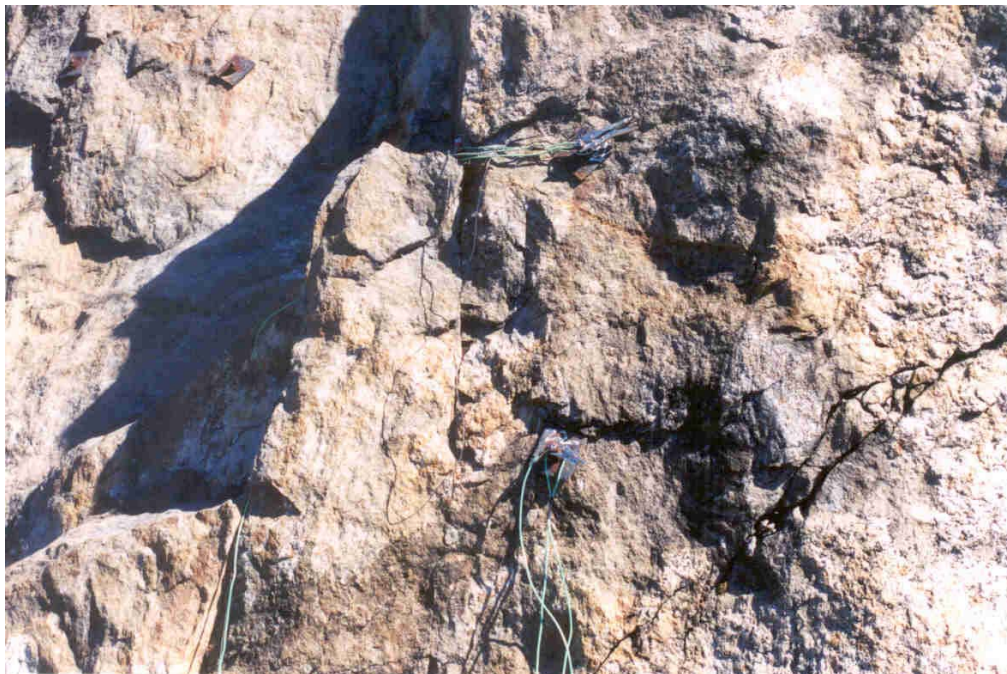
Photograph 16 – Half-cell location for Bolts 21 and 22. Half-cell was placed in the crack approximately 3 feet to the left of Bolt 21.
